Wairoa

CYCLONE GABRIELLE REVIEW

Andrew Newman

Strome
Advisory

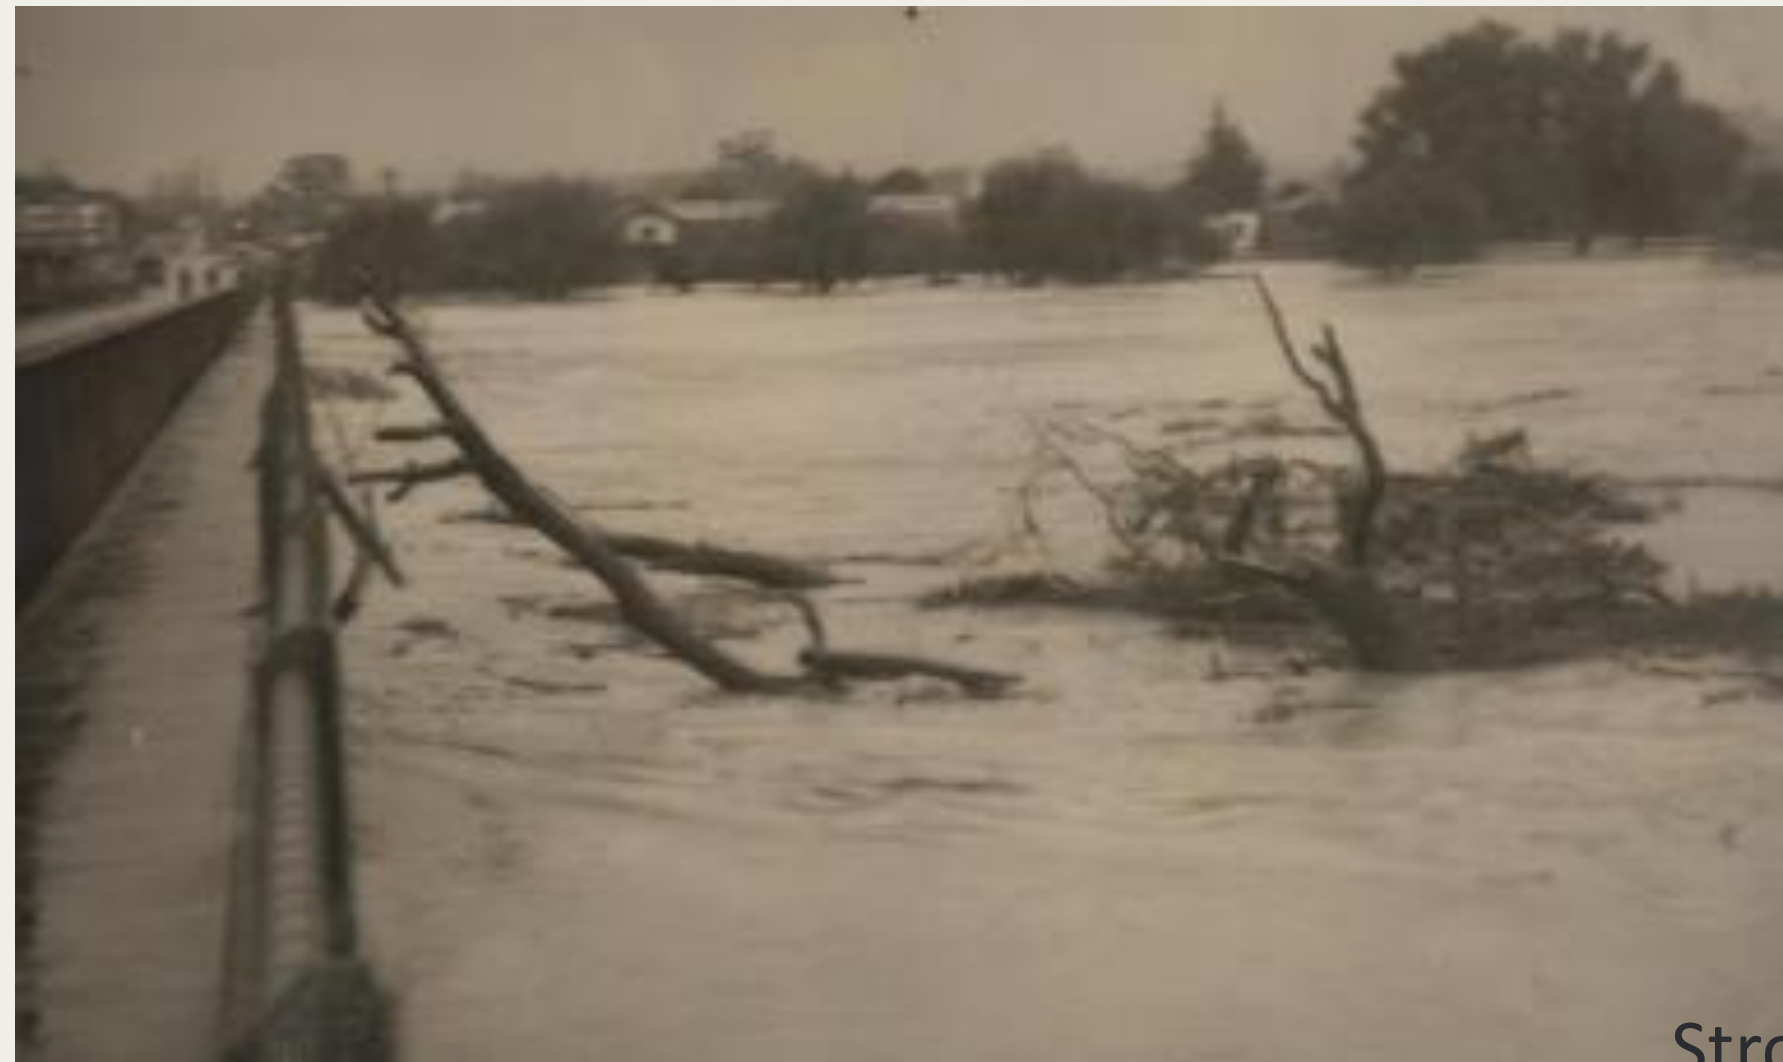
Figure 2 - Woody Debris approaching Wairoa Bridge likely 1948 storm

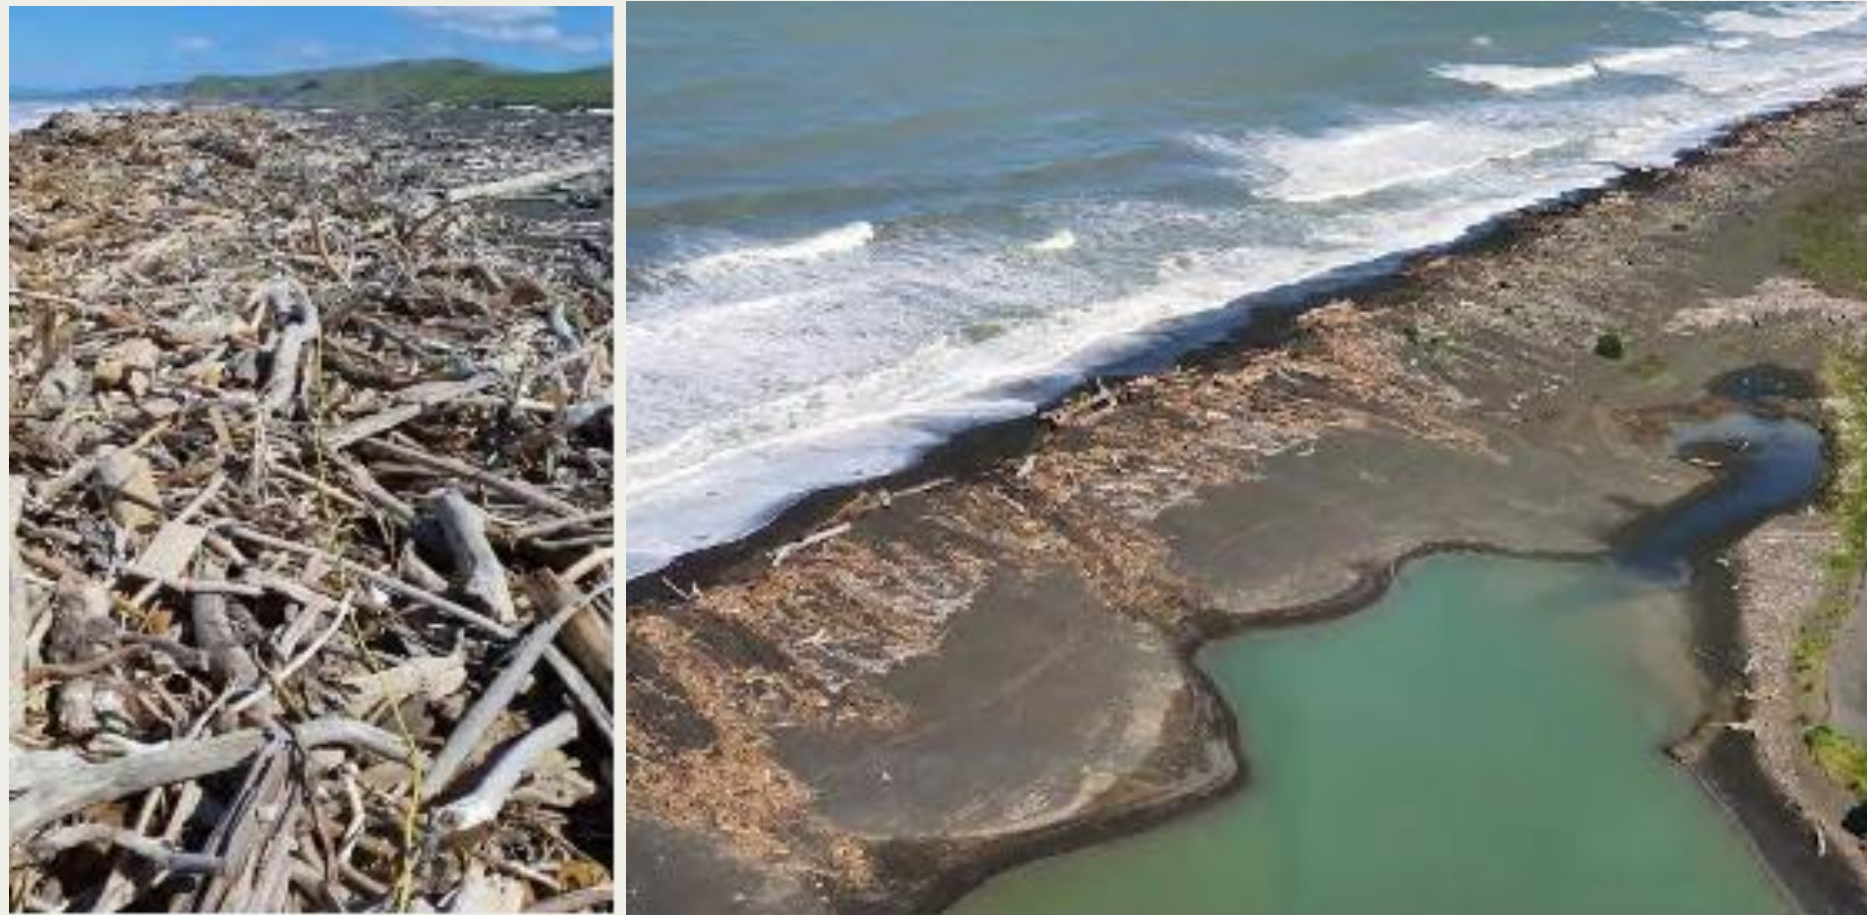
Figure 3 – wood debris on Wairoa Bar post Gabrielle – source Interpine woody debris survey for HBFG

Hawkes Bay Forestry Group (HBFG) woody debris survey at the Wairoa mouth suggests by volume – 36% poplar willow, 29% pine (2% slash
29% native, balance other

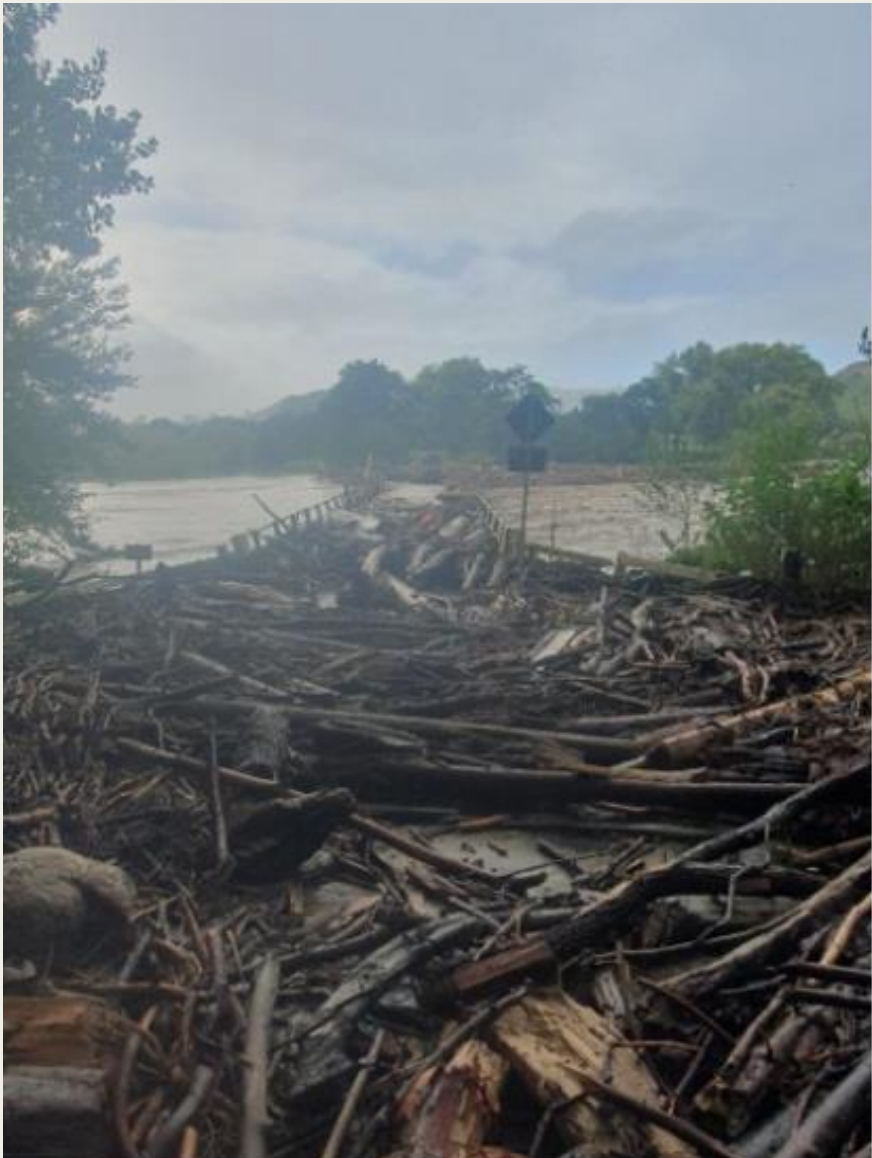
Figure 4 Mixed Woody Debris on Riverina Bridge, Marumaru during Gabrielle – approx. 7 am February 14 2023

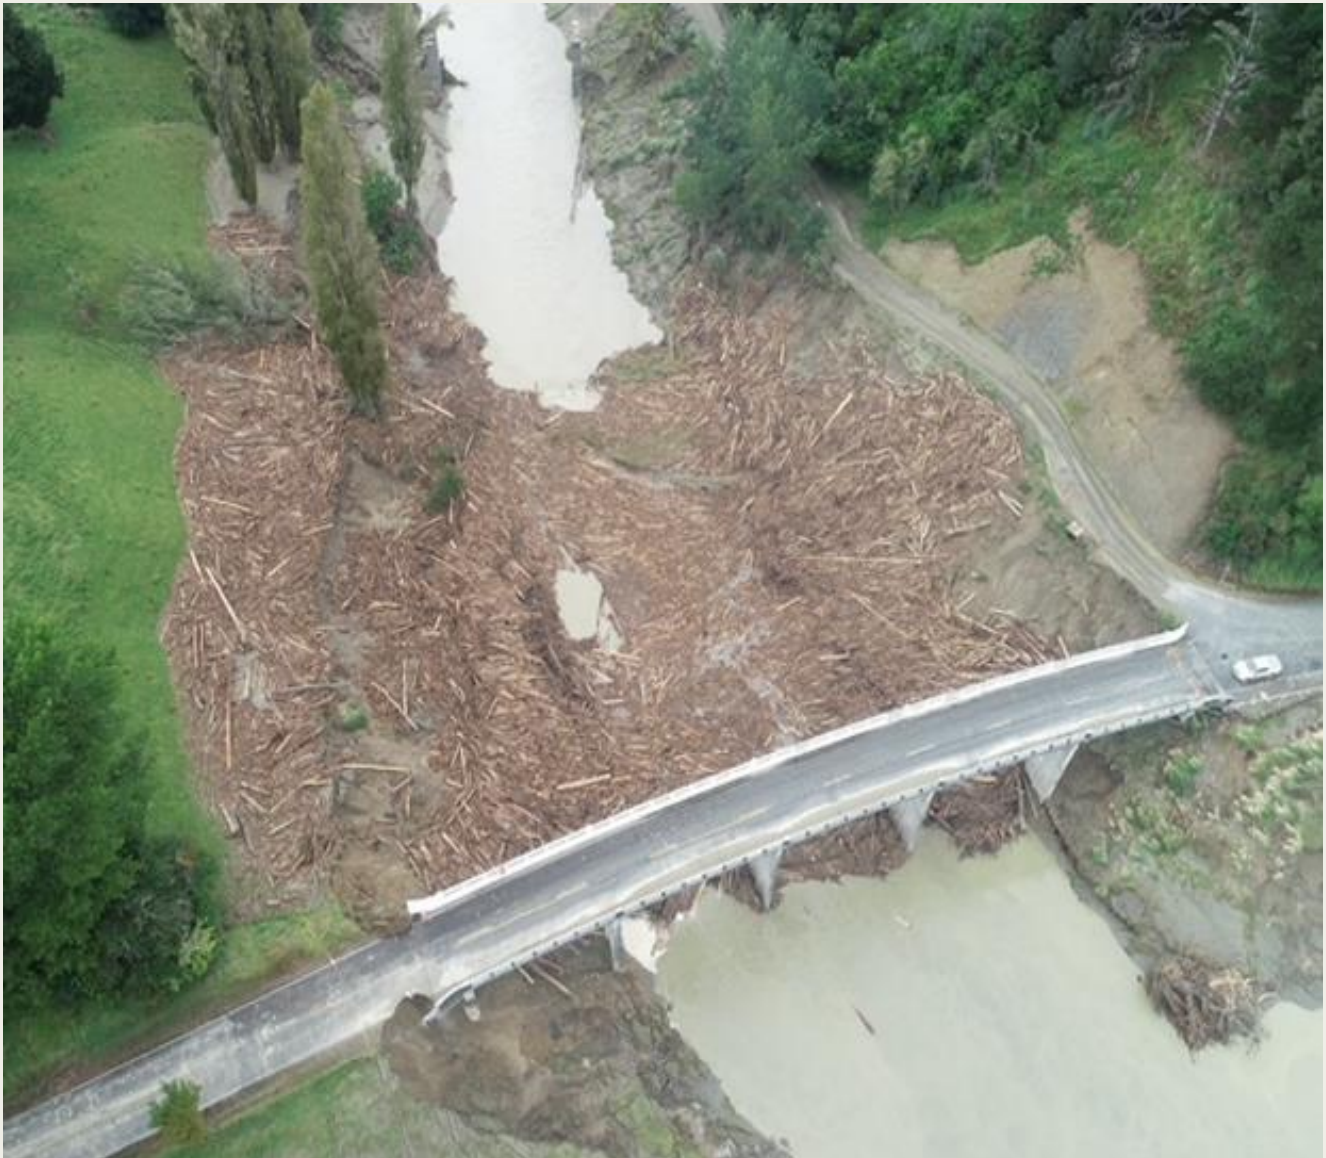
Figure 5 – woody debris behind Kotare Bridge – mainly pine but not physically surveyed

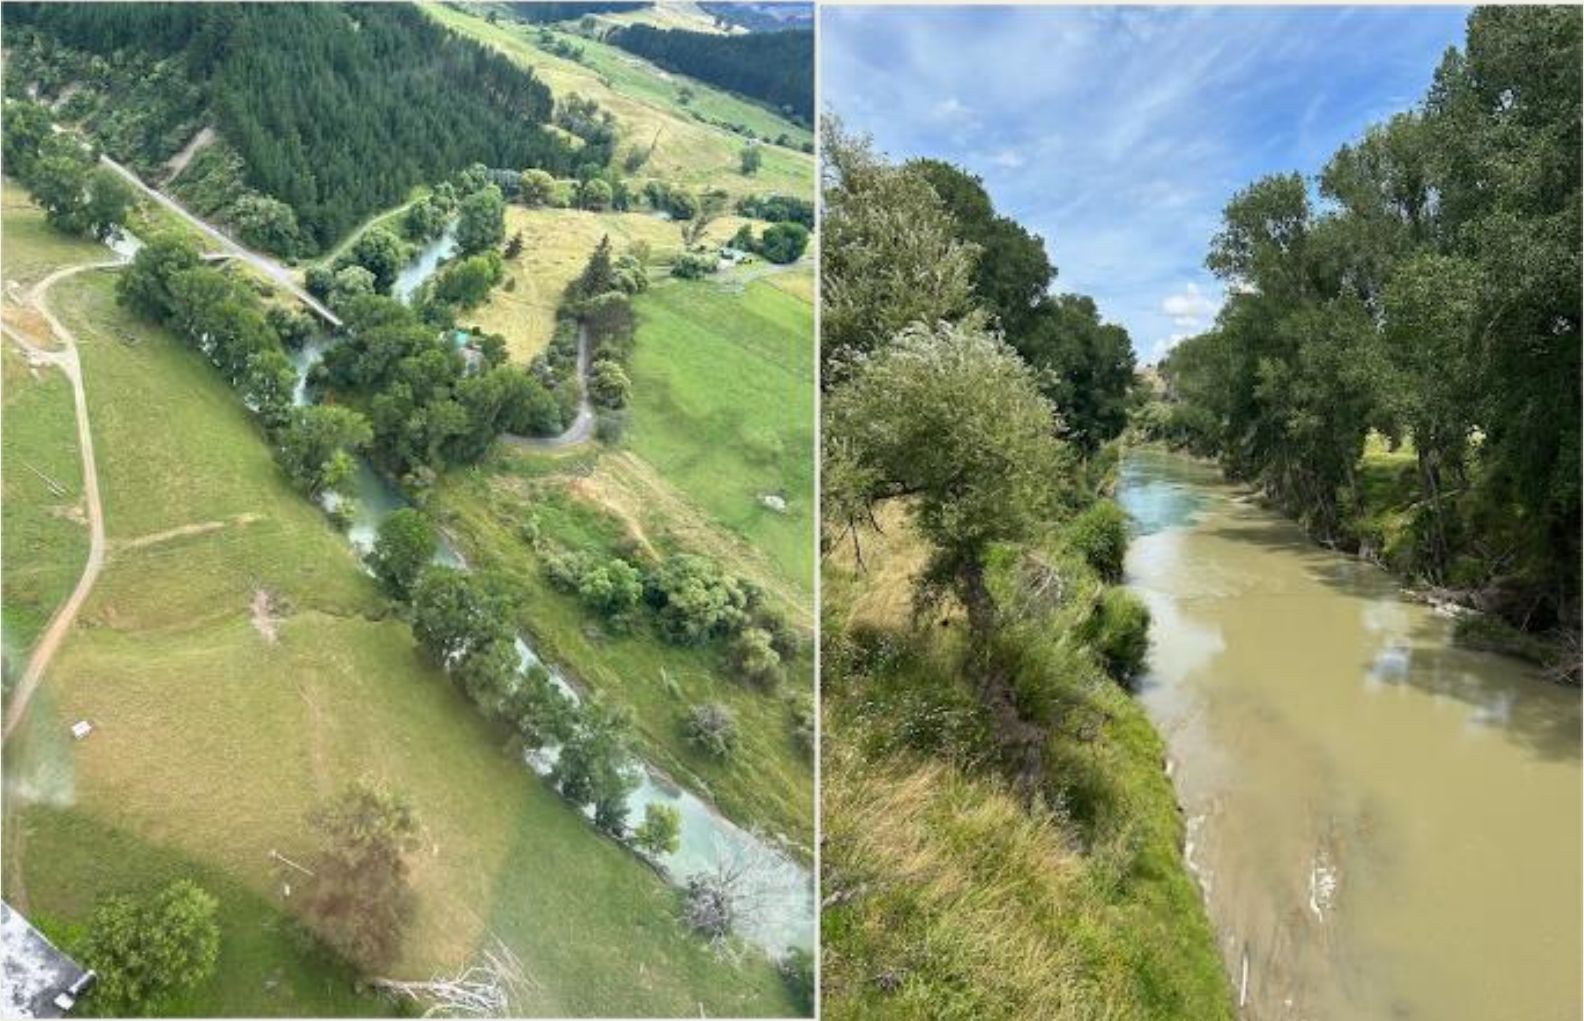
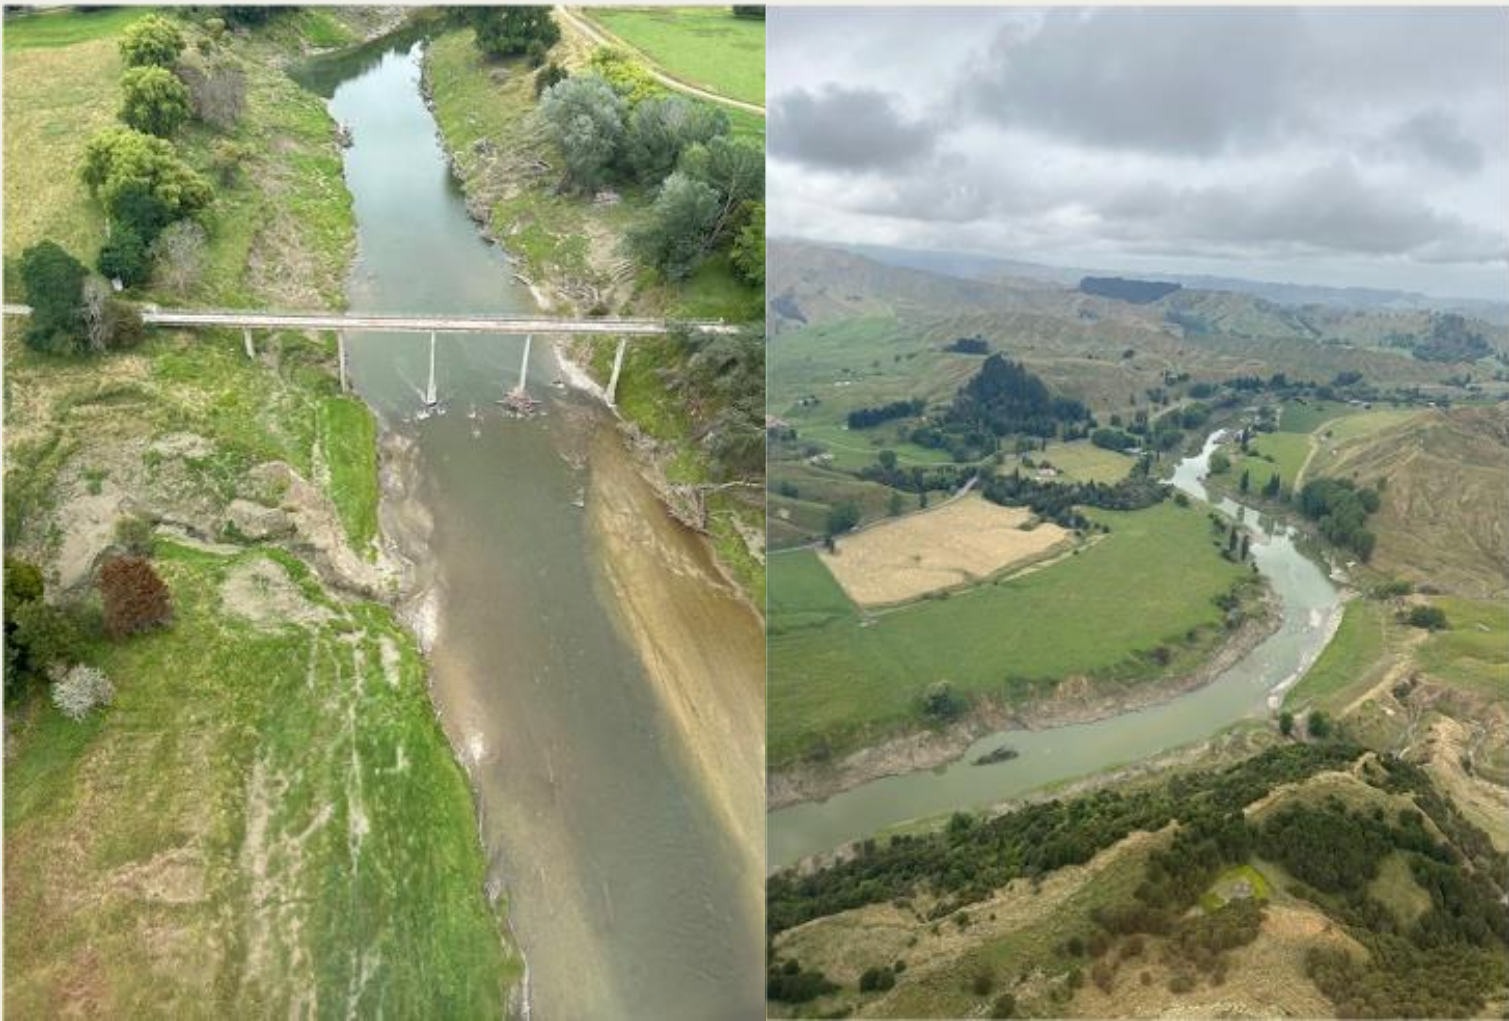
Figure 6 & 7 below illustrate both the incidence of the poplars on the Waikaretaheke and Waiau confluence.

Figures 8 & 9 Wairoa post Gabrielle indicating significant bank scouring.

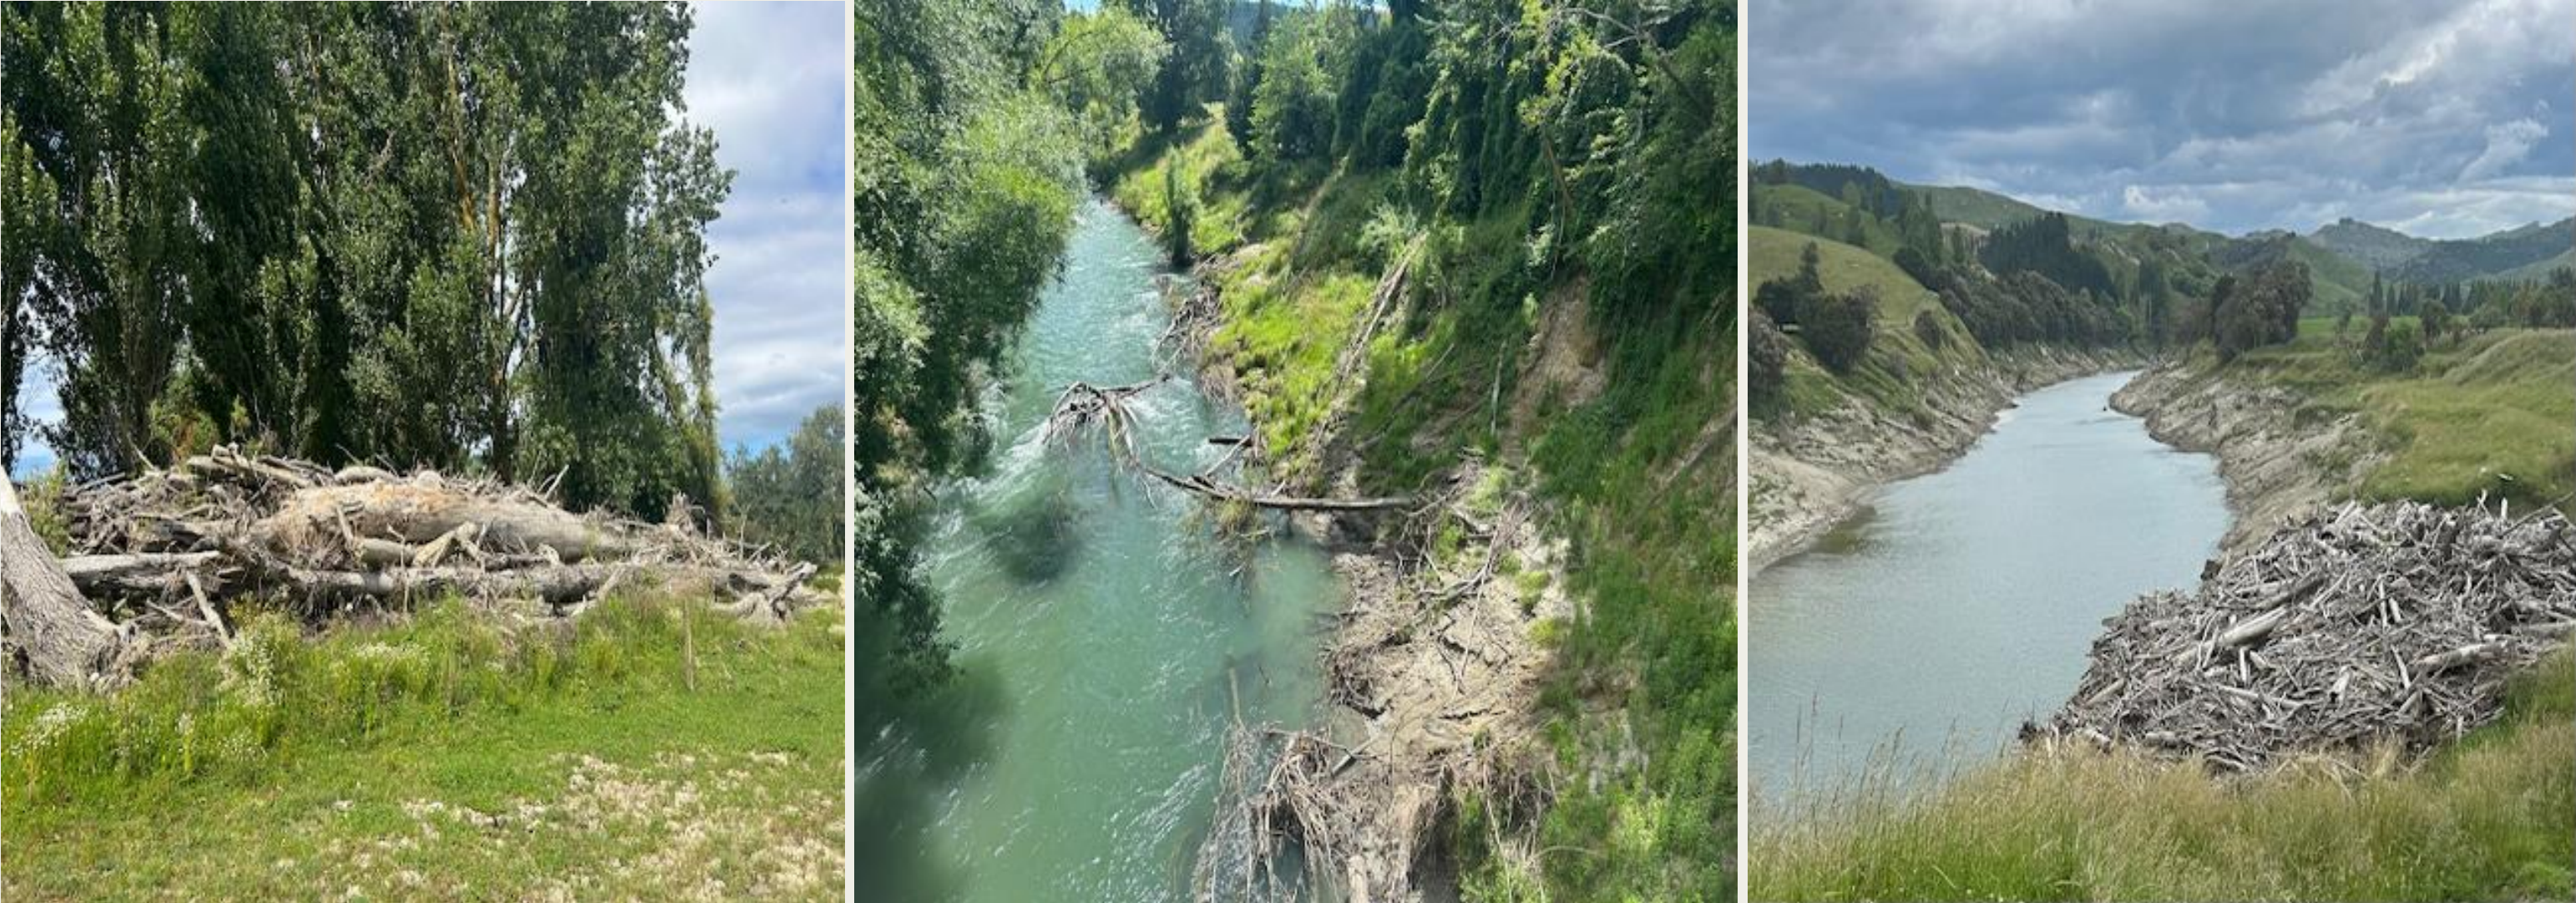
Figures 10, 11, 12 - poplar flood debris just upstream of the rail bridge and in the Waikaretaheke, and woody debris adjacent to the Wairoa tributary

- As noted in section 5.2 significant woody debris banked up against the rail bridge.
- Local recollections note that there was a backflow on the upstream side of the bridge with the water level (anecdotally) approximately 1-1.5 m lower on the downstream side at or near peak flow - approx. 8 -11 am.

- The Rail Bridge effect at most was likely to have been a slowing of flow velocity into North Clyde and some back flow, potentially raising water levels in adjacent farmland just upstream.
- More accurate than this is the response provided by the Flood Flow Modelling engineer of HBRC.

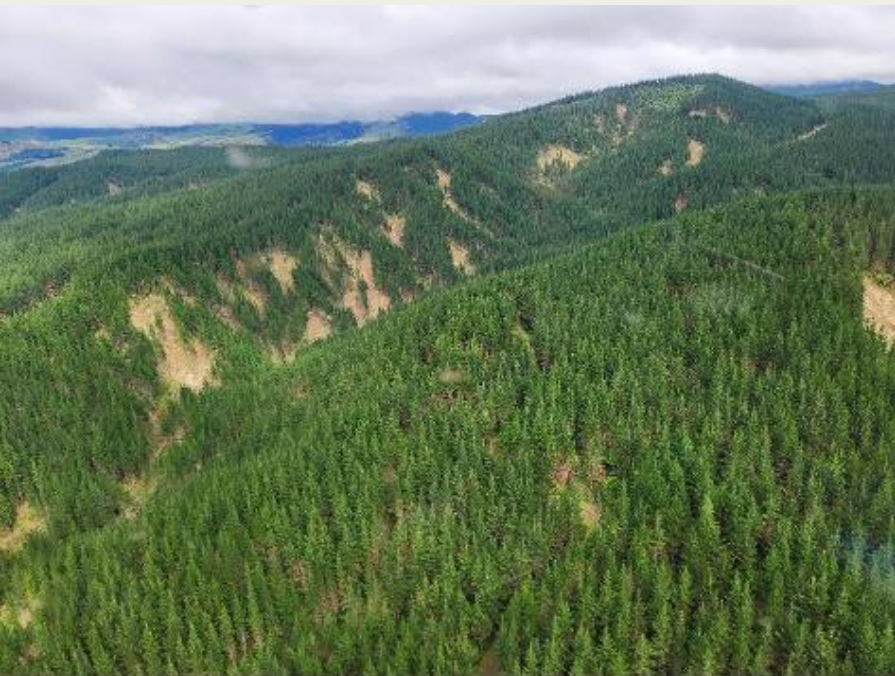
Figure 15 'mid slope failure' Waikare Forest

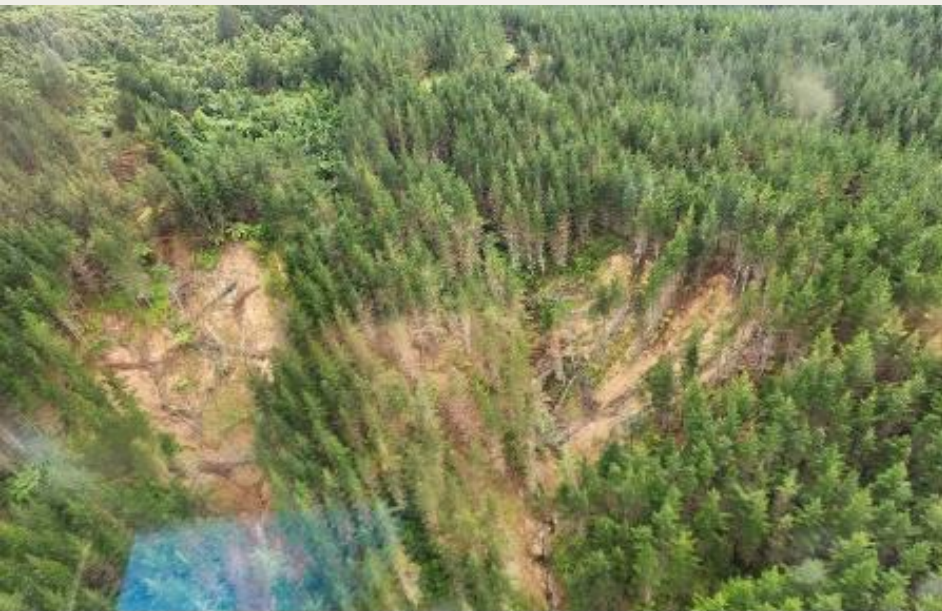
Figure 17 - Windthrow in Forest in the Ruakituri area

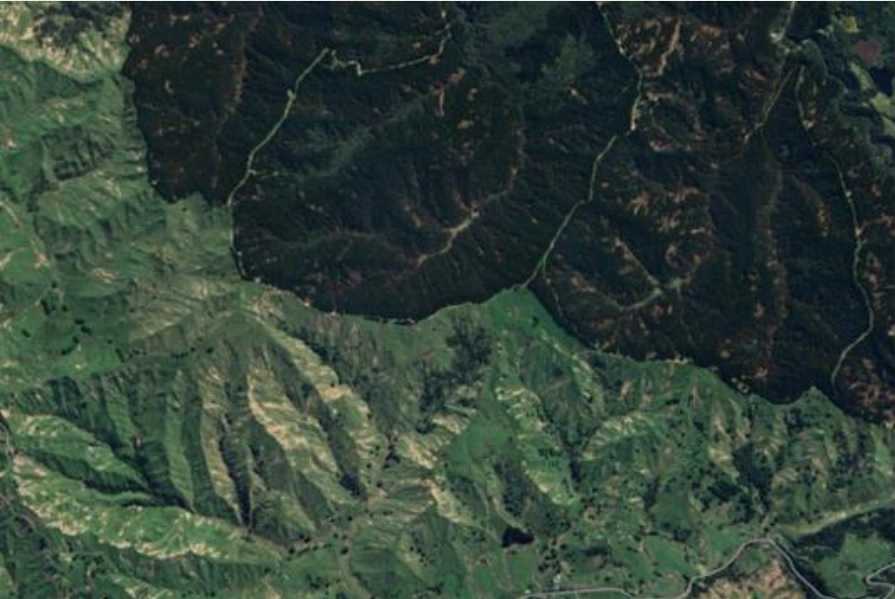
Figure 16 Google Earth image of storm damaged forest & farmland between Mangapoike Tiniroto roads

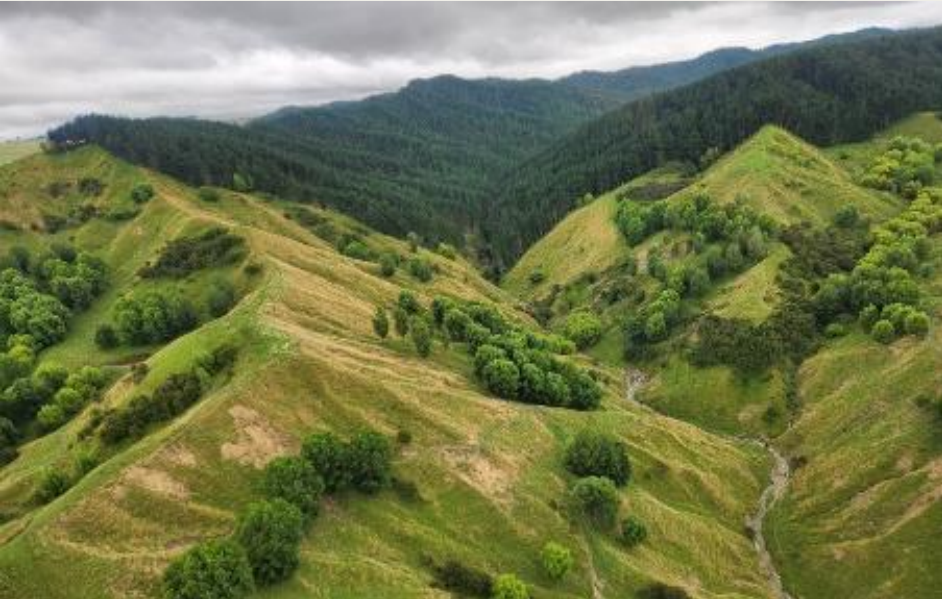
Figure 18 intact forest/farmland near Frasertown

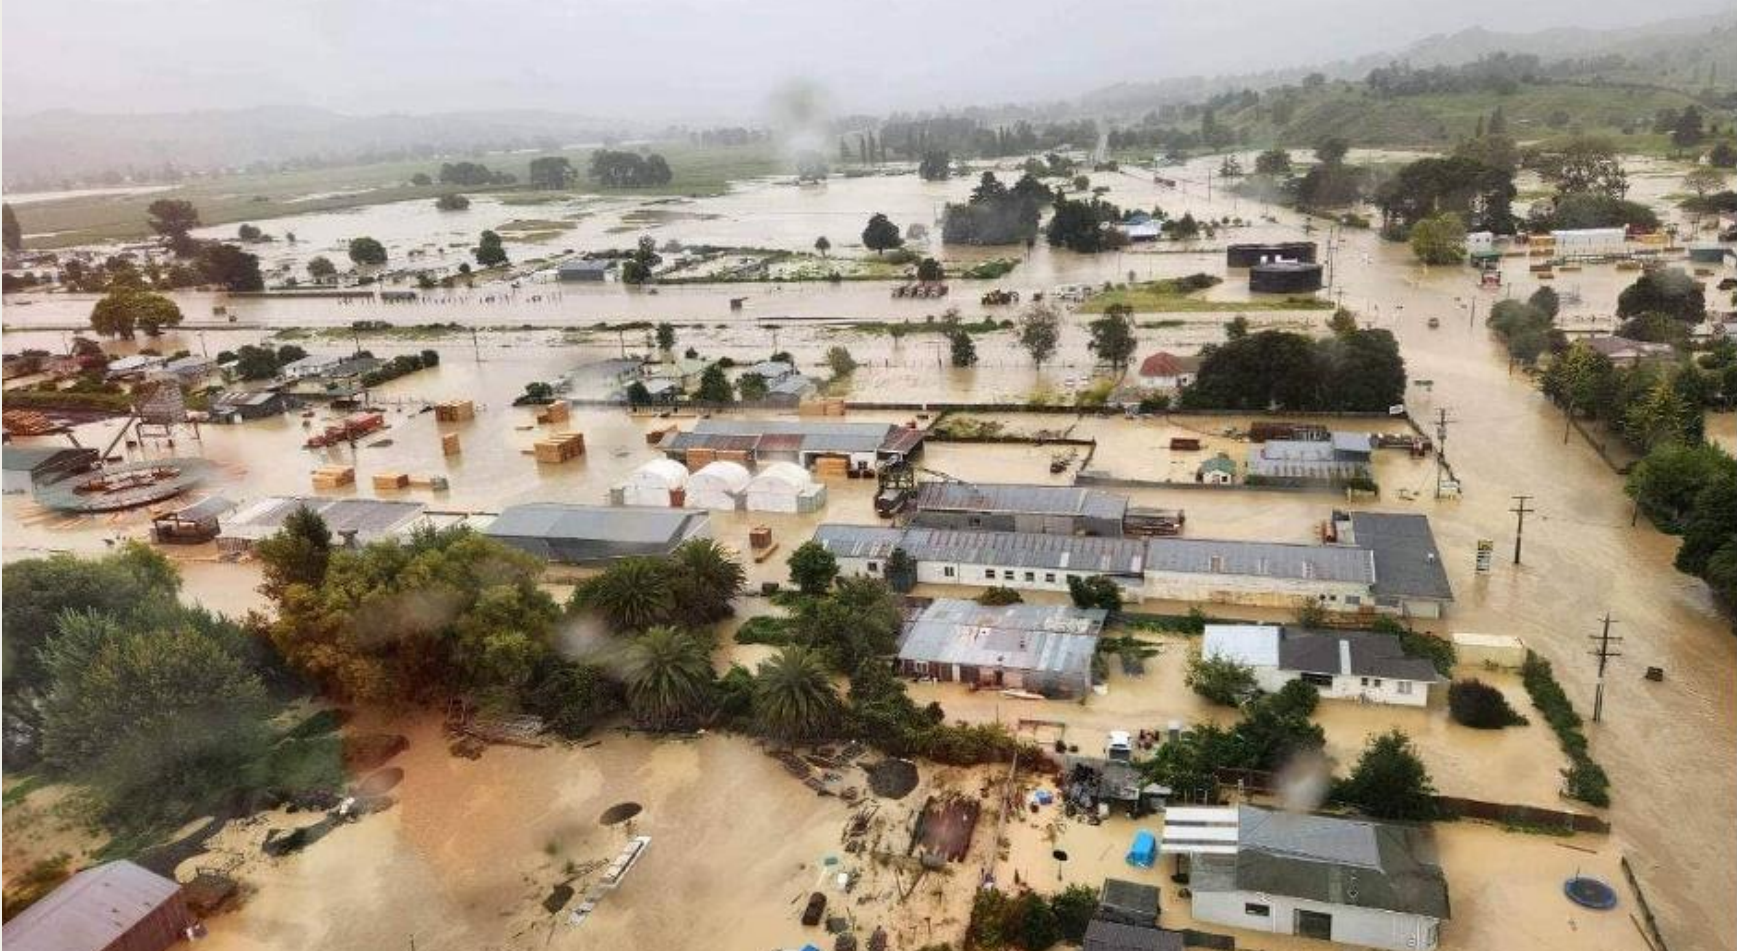
Figure 20 North Clyde morning of 14 February 2023

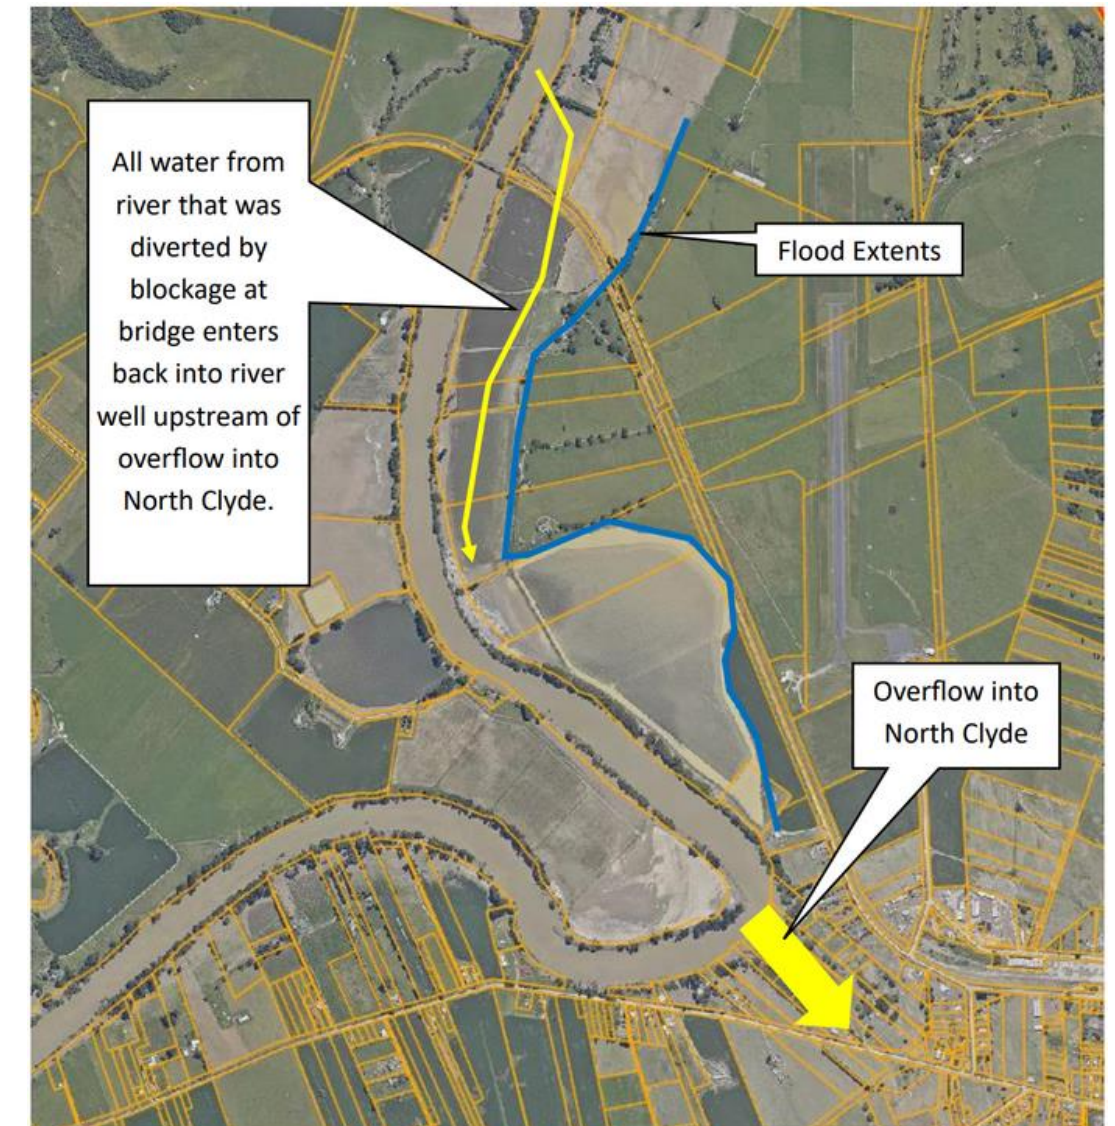
As demonstrated below {to the right} in figure 6, the effect of blockage at the railway bridge would only have an effect of reducing the overflow into North Clyde. Imagine if the rail bridge could block a huge portion of flow and maintain the water in the channel (i.e., no out of channel flow). This would result in water arriving at the overflow into North Clyde at a slower rate and would result in lesser flooding. As a corollary, if there was no blockage at the rail bridge, the water would arrive at the North Clyde overflow earlier, and with a higher discharge, causing worse flooding.
