Hawkes Bay Regional Council

# WAIROA LAND CATEGORISATION IMPACT OF WOODY DEBRIS AND THE WAIKAREMOANA POWER SCHEME

7 MAY 2024

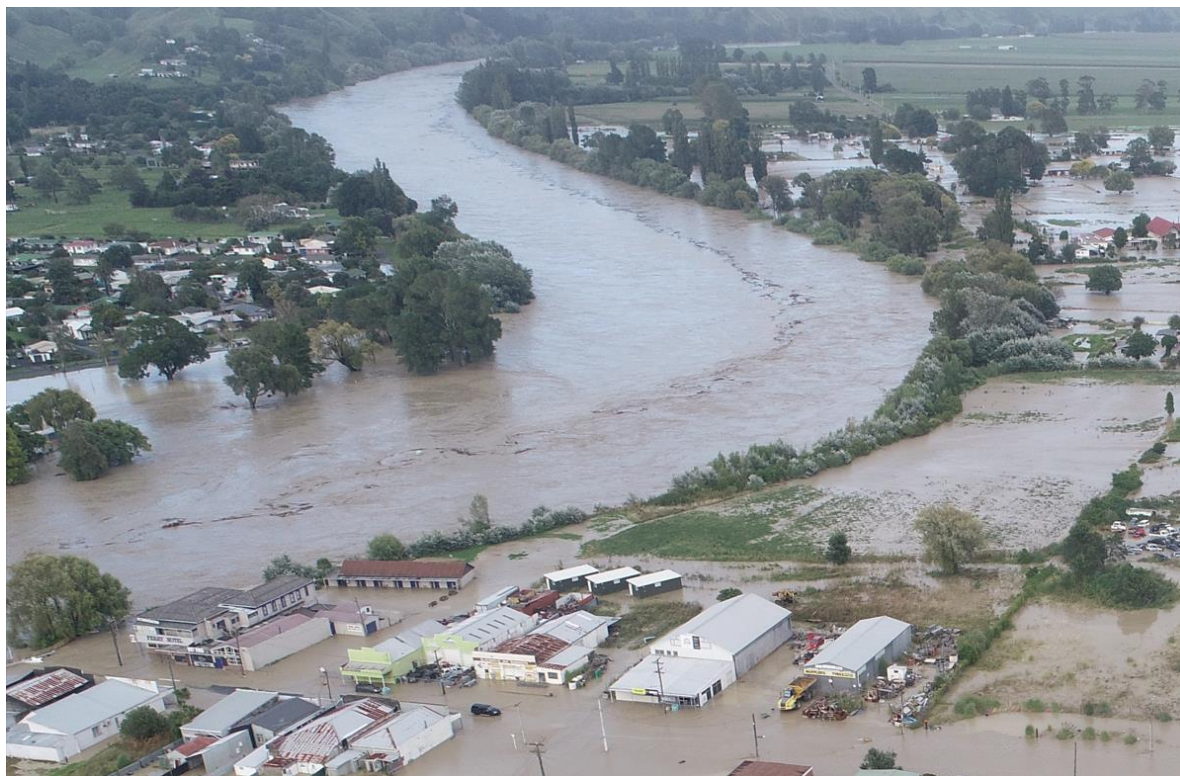
Figure 1 – LWD forming a line along the Wairoa River – this line typically follows the deepest part of the channel.

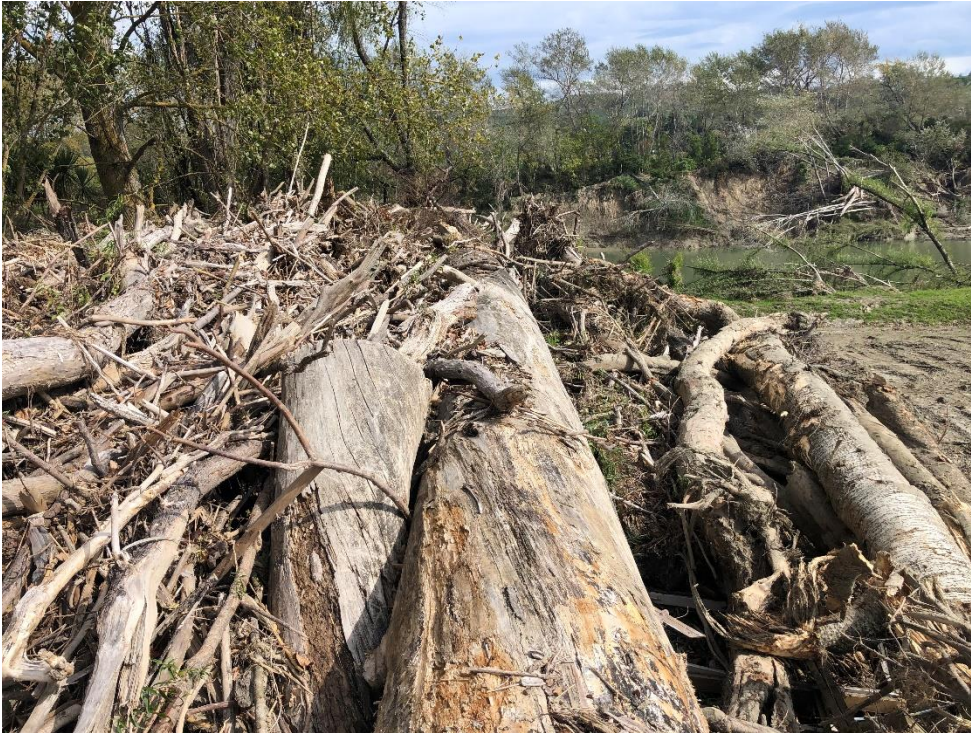
origin and was likely sourced from stream bank erosion, and ironically, had likely been planted along riverbanks to prevent erosion.

Figure 2 – Woody debris accumulated post cyclone along the river margin. The largest material appears to be Poplar.

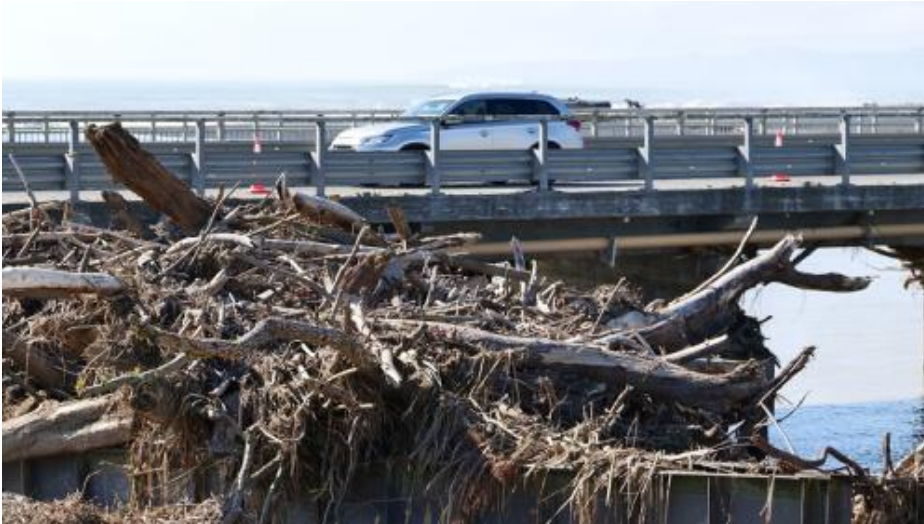
Figure 3 – Awatoto River Bridge, Image courtesy of HBRC

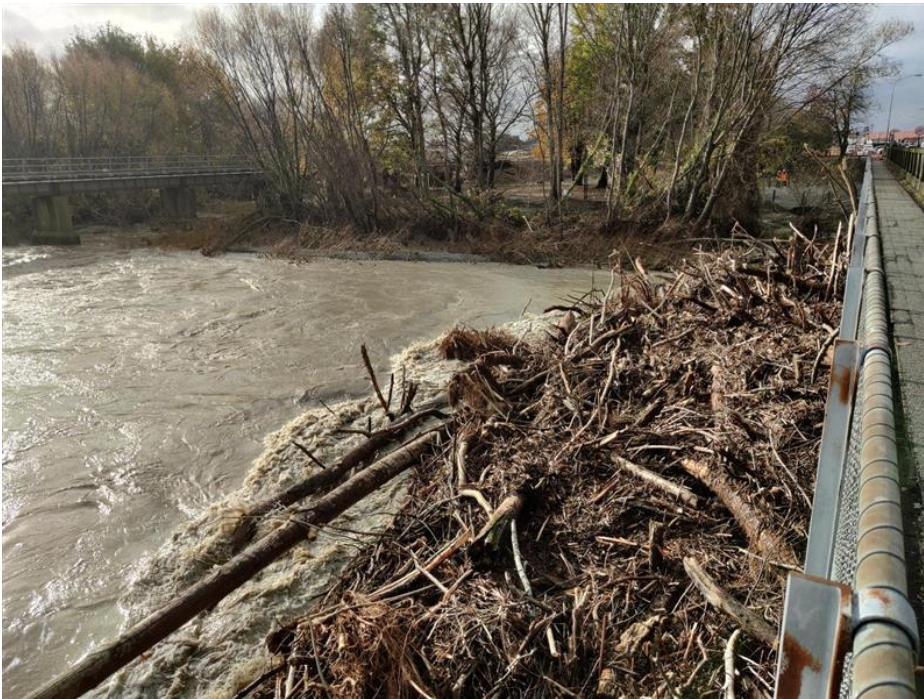
If the river level exceeds the underside of the bridge, a much larger 'matt' of debris can also form which can further restrict flow under the bridge.

Figure 4 – Debris matt against the Ashburton River Bridge, Canterbury

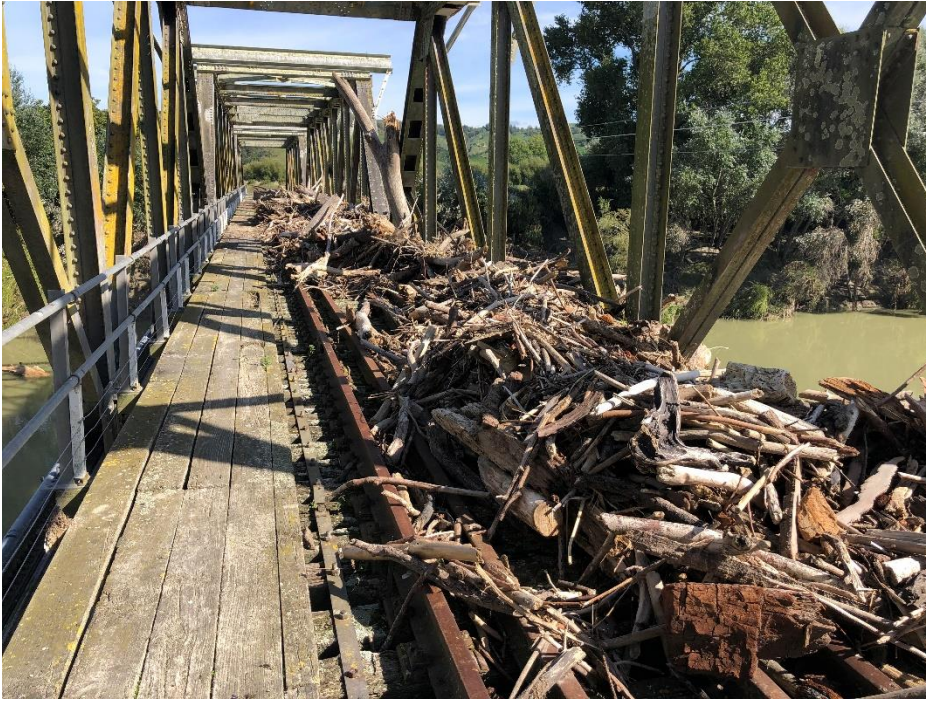
In the case of the Palmerston North Gisborne Line (PNGL) rail bridge, the debris trapped there would have increased upstream flood levels and contributed to the failure of the approach embankment. The rate at which this failed though is unlikely to have created a sudden and significant release of impounded flood water or contributed in any significant way to the flooding in Wairoa.

In the case of Wairoa, the PNGL rail bridge upstream of the town trapped a large amount of LWD which was pushed up onto the deck of the structure (see Figure 5). Some of the Wairoa community believe that this bridge formed a 'dam of debris' which then breached and released a surge of flood water. There is certainly evidence that the rail embankment at the bridge approach was washed out and failed, so such a scenario is plausible.

Figure 5 – Debris on the PNGL rail bridge. Image courtesy of HBRC.

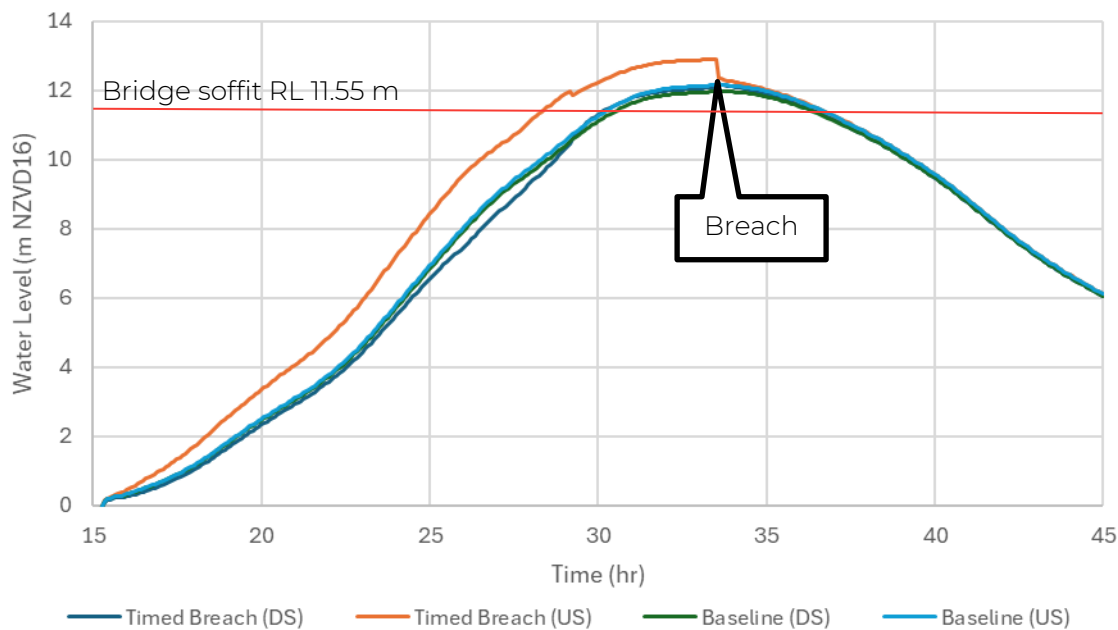
Figure 6 – Predicted water level at the rail bridge for the breach scenario ('Time Breach') and without a breach ('Baseline').

However, a sudden release of impounded water at the rail bridge, or upstream, is not supported by the level data recorded by HBRC at the rail bridge which is considered reliable. The observed level data does not show a sudden drop or increase in the upstream water level that would be commensurate with a sudden or rapid release of water (at least not within the frequency of observations) that would be indicative of a rapid release of water. If a sudden release of water had occurred at the rail bridge, you would expect to see a sudden drop in water elevation upstream of the bridge (the location measured by the gauge) as indicated in Figure 6.

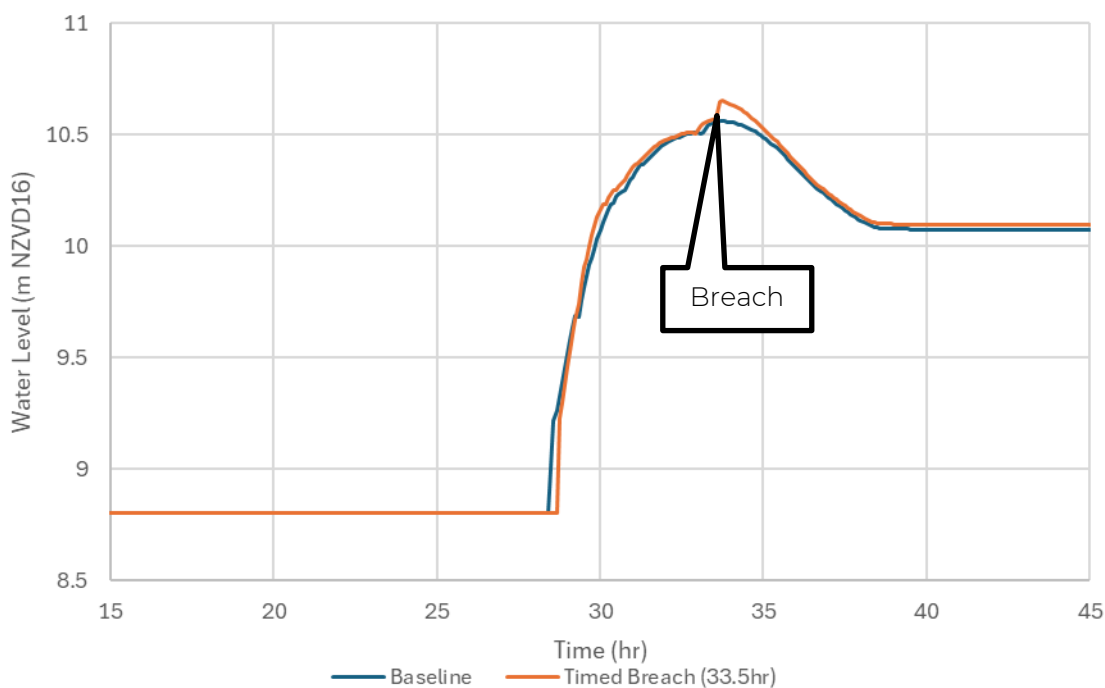
Figure 7 - Predicted water level in North Clyde for the breach scenario ('Time Breach') and without a breach ('Baseline').

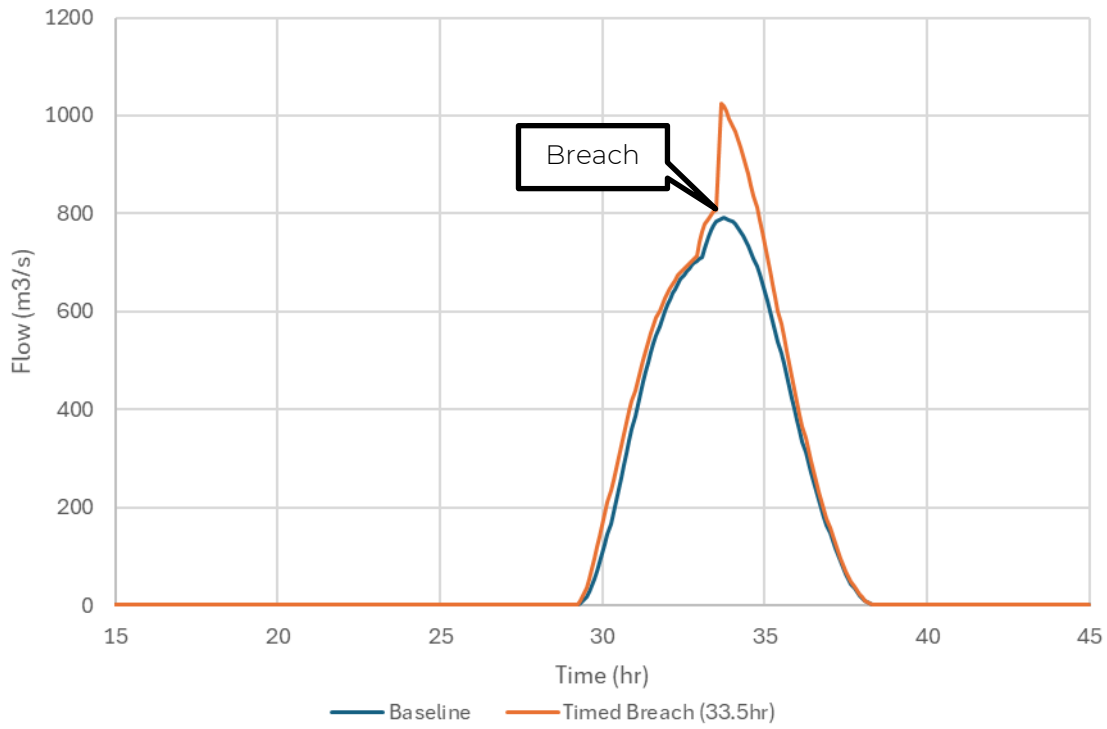
The results of this assessment indicated that such a breach could have a notable effect on the flood flow entering North Clyde. Flow out of the Wairoa River into North Clyde was simulated to increase from approximately 800 m<sup>3</sup>/s to 1010 m<sup>3</sup>/s. However, the corresponding flood elevation did not change significantly with this flow increase, with the additional pulse of flow increasing the flood elevation only in the order of 0.09 m.

Figure 8 - Predicted flow into North Clyde for the breach scenario ('Timed Breach') and without a breach ('Baseline').

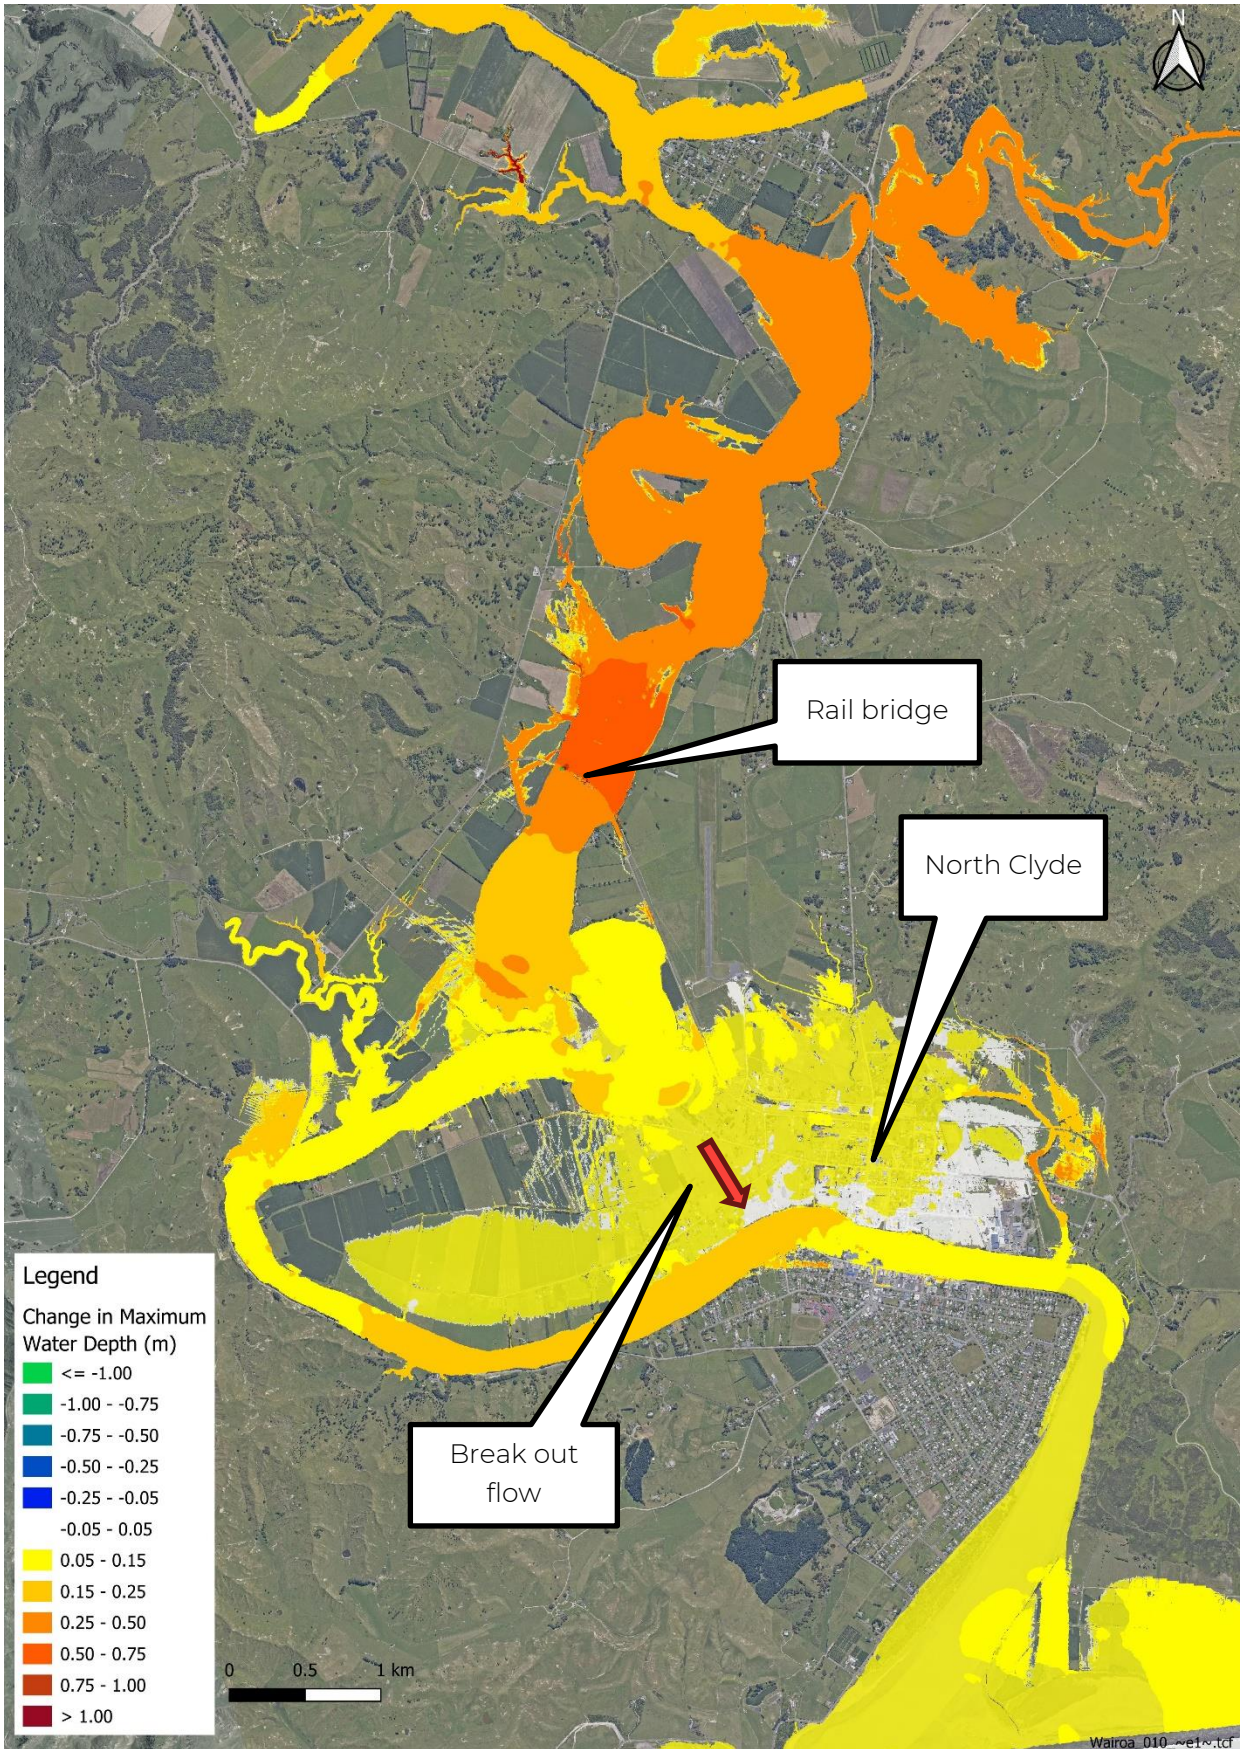
Figure 9 – Change in flood depth for the breach scenario versus no breach.

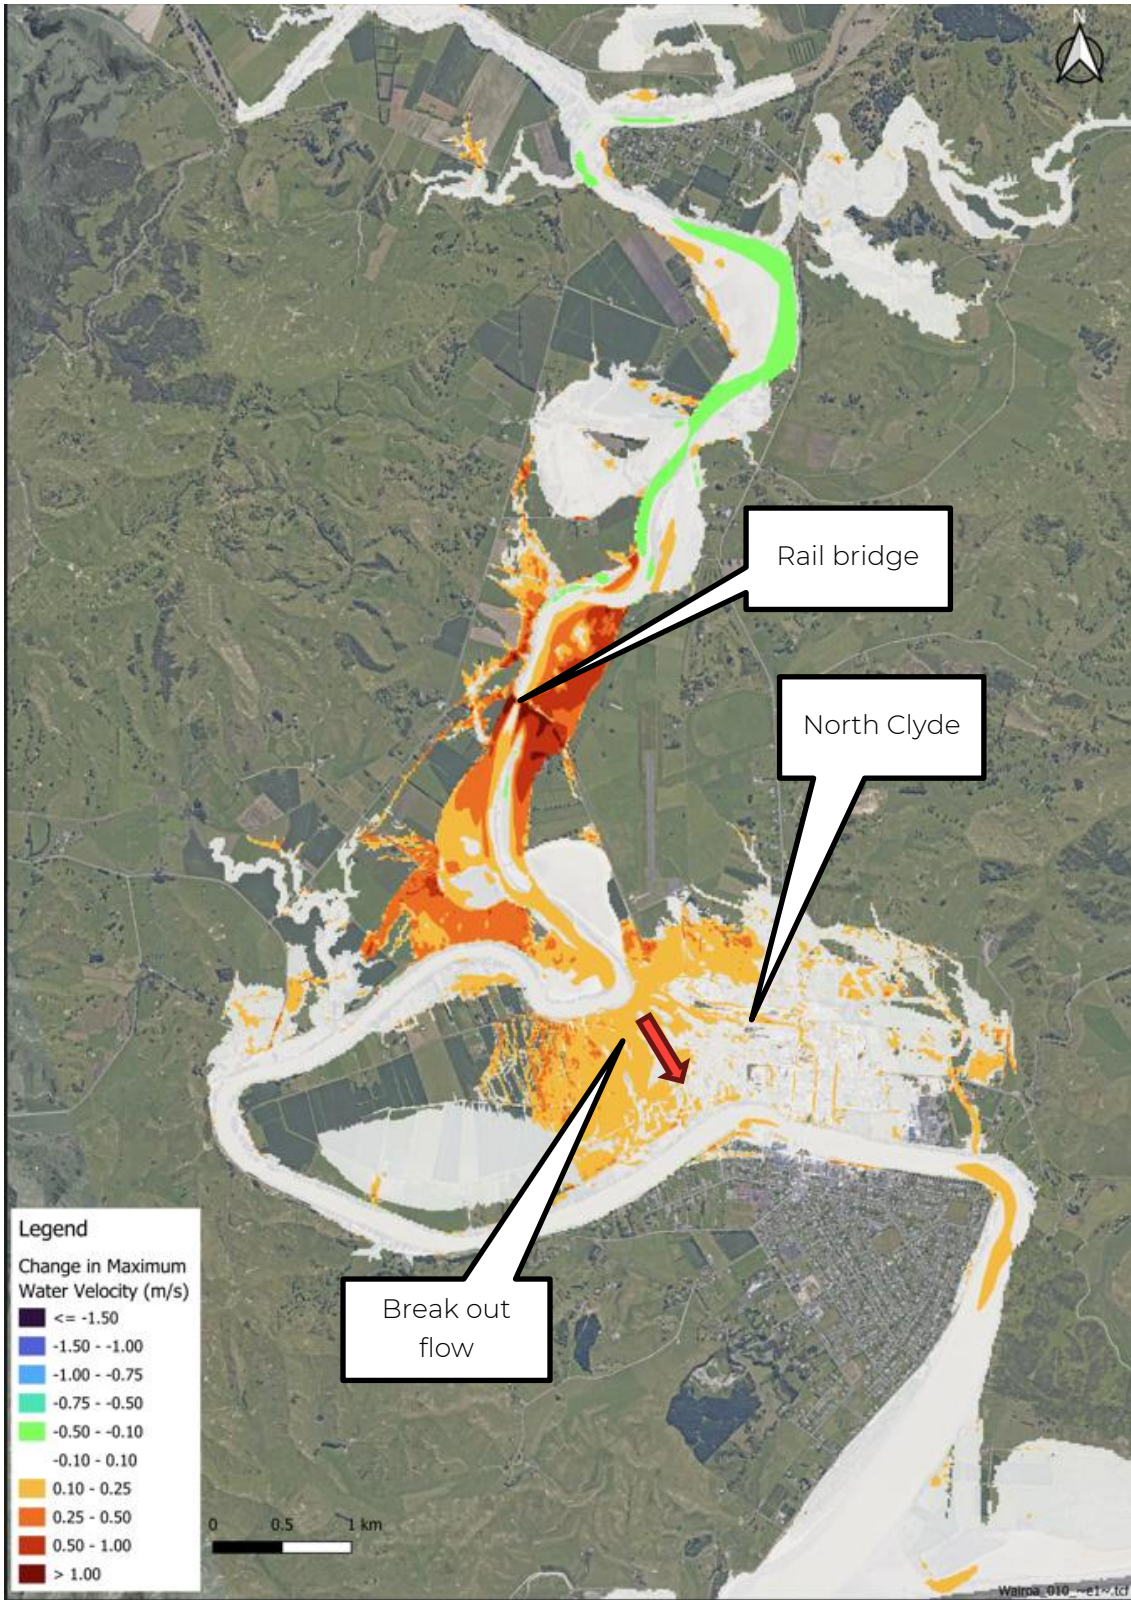
Figure 10 - Change in velocity for the breach scenario versus no breach.

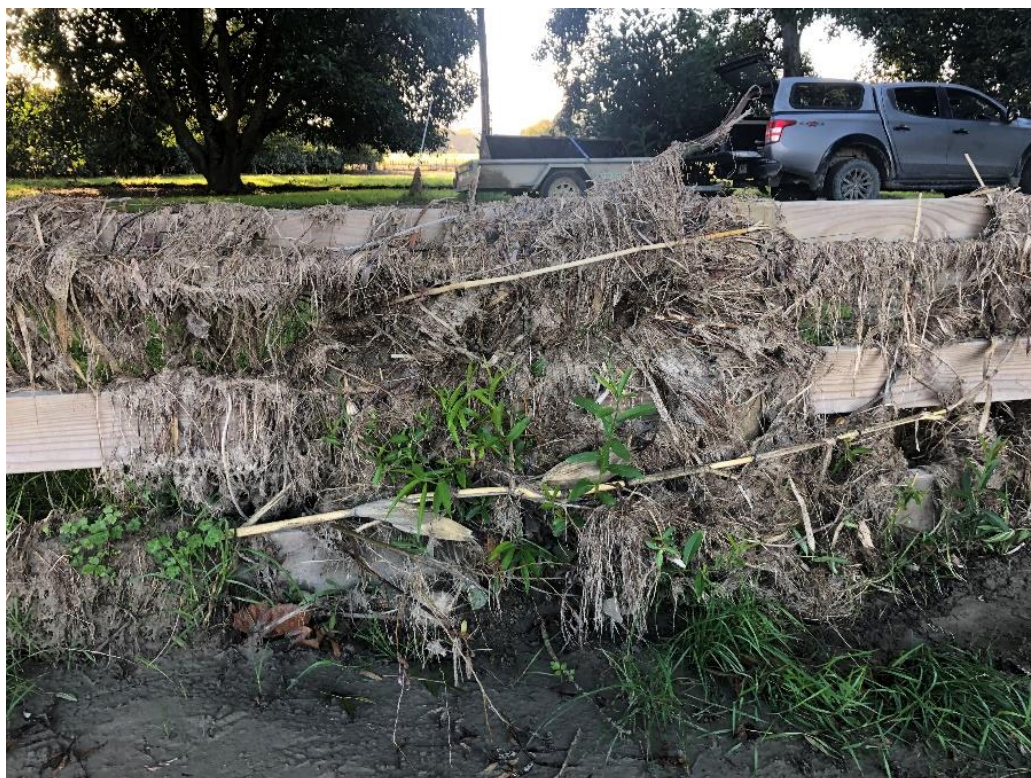
Figure 11 – a fence covered with flood debris or 'wrack' (Wairoa). Such structures can influence how flood waters move through an area.

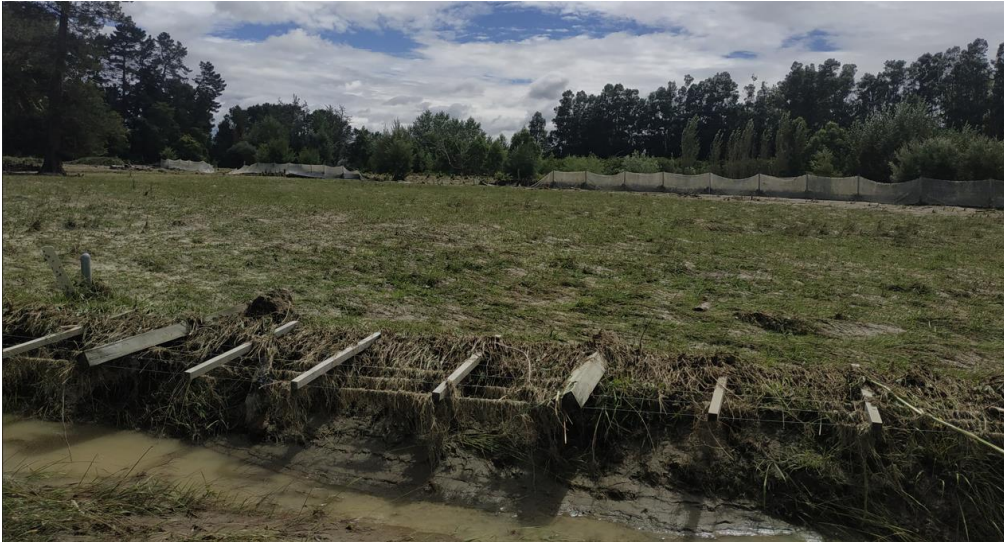
Figure 12 – a fence flattened by the force of water (Wairoa) – such failures can create sudden surges of flood water.

Water overtopping the banks would likely have pulsed due to turbulence in the main river and the complexities of a rural – urban flood plain would have further complicated the movement of water, with structures such as a collapsing fence forming sudden pulses of flood water.
