## WSP ARCHAEOLOGICAL SCREENING: WAIROA FLOOD CONTROL OPTIONS: NORTH CLYDE, HAWKE'S BAY

An archaeological risk screening of proposed flood control options for North Clyde, Wairoa has been requested from Archaeology Hawke's Bay Ltd (AHB) by Andrew Sowersby (WSP) on behalf of HBRC, WDC and Tatau Tatau o te Wairoa. At this stage the screening is a desktop exercise only and is intended to provide guidance around potential risks and considerations in moving forward with the decision-making process.

WAIROA FLOOD CONTROL OPTIONS  
JAN 2024

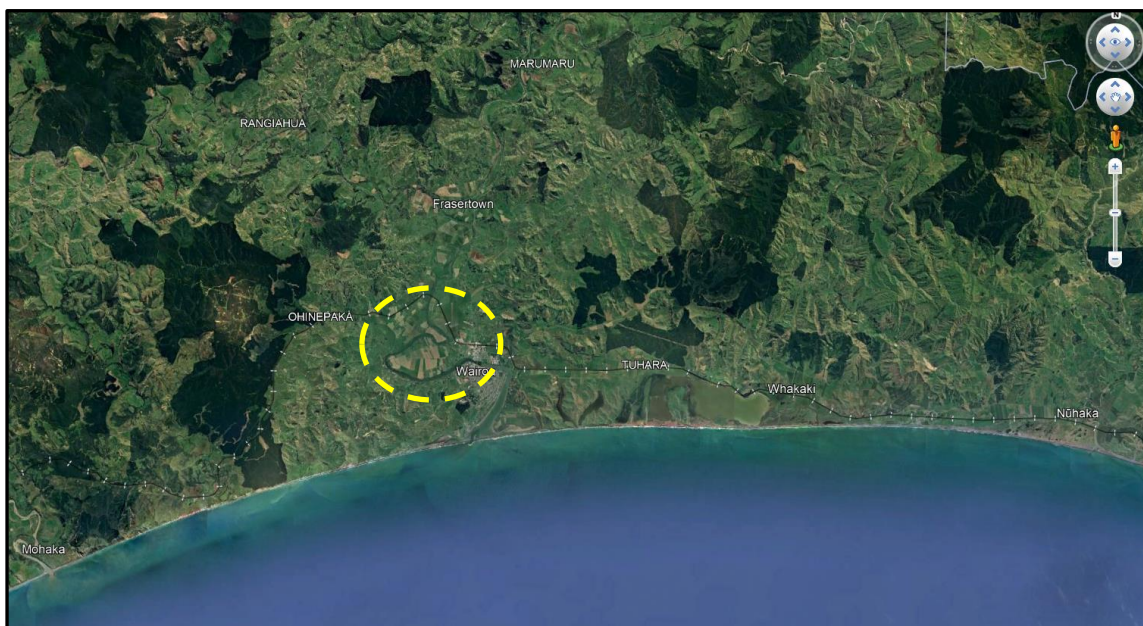
This screening relates to sections of the Wairoa River affecting the North Clyde area of Wairoa (see images below).

General area of proposed work (Source: GoogleEarthPro).

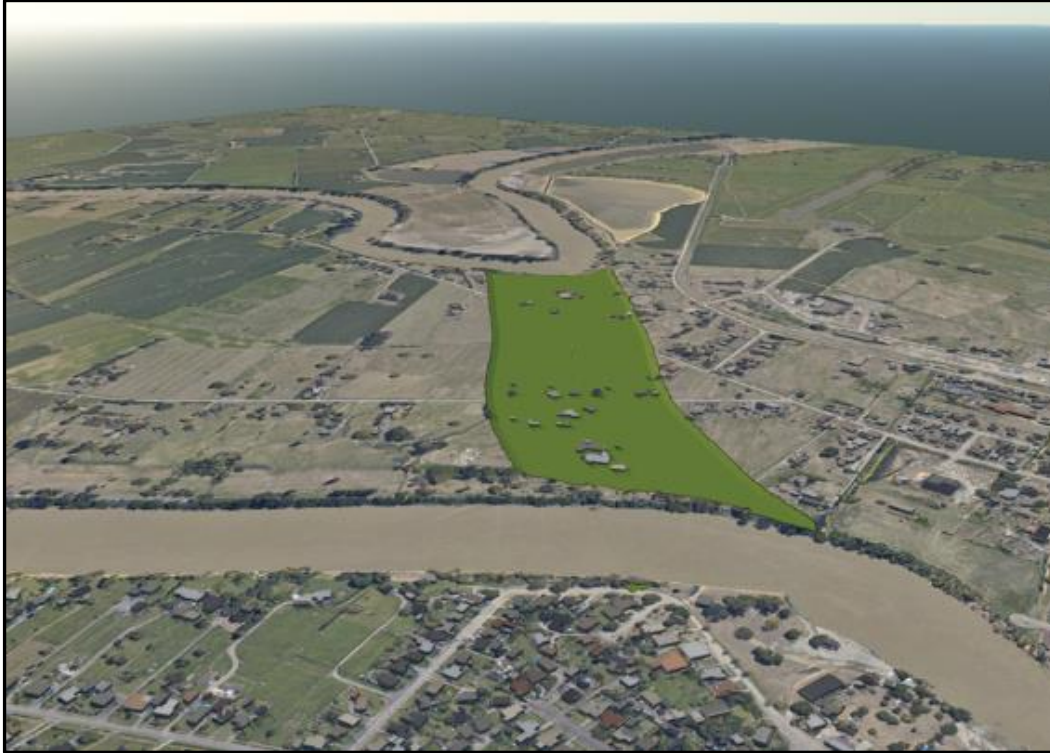
Option 1: Floodway

Floodways are described as wide drains excavated 2 – 3 m deep to allow the flow of water to bypass the channel (A. Sowersby pers comm). Stop banks will likely require some extent of turf stripping and excavation to 'good' ground for engineering purposes. There may also be a requirement to quarry material locally to create the stop banks (based on personal experience with similar projects to date). A buffer of circa 50 m has been applied to the stop banks to allow a generous work corridor. Earthwork beyond this assumed extent will require revision case by case.

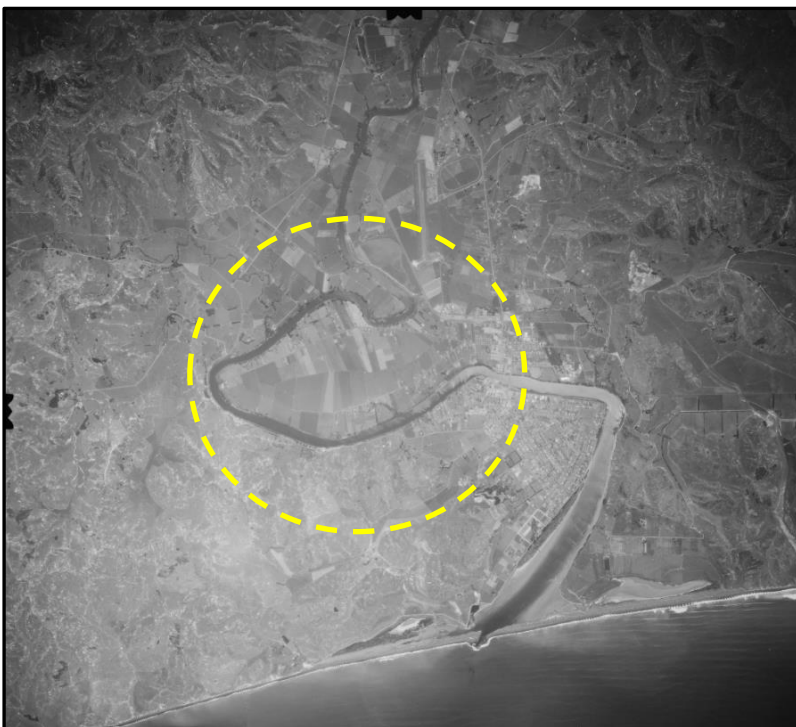
Several historic aerial images dating from the 1940s were scanned for information relating to the recent history of modifications to the river alignment and for potential unrecorded archaeological sites that might be affected by the proposed work. Indications are that the course of the river has changed very little through this section since that time, and by 1978, the earliest overview of the whole section, it is in its current alignment.

These images were not scanned for archaeological indicators as much of the affected area has been cultivated and thus any surviving features such as pits will likely have been obscured from surface view. It is noted however that elements of X19/35 as reported in the site record form could clearly be seen in several 1942 aerial images. Therefore, at a later stage in this process further screening of aerial imagery would be of value but it is not considered to contribute greatly to this stage of screening.

Retrolens image from 1978 showing the considered section of the river largely as seen today.
